DEPARTMENT OF THE INTERIOR
UNITED STATES GEOLOGICAL SURVEY

THE
SAN FRANCISCO EARTHQUAKE AND FIRE

APRIL 18, 1906

AND THEIR EFFECTS ON STRUCTURES AND
STRUCTURAL MATERIALS

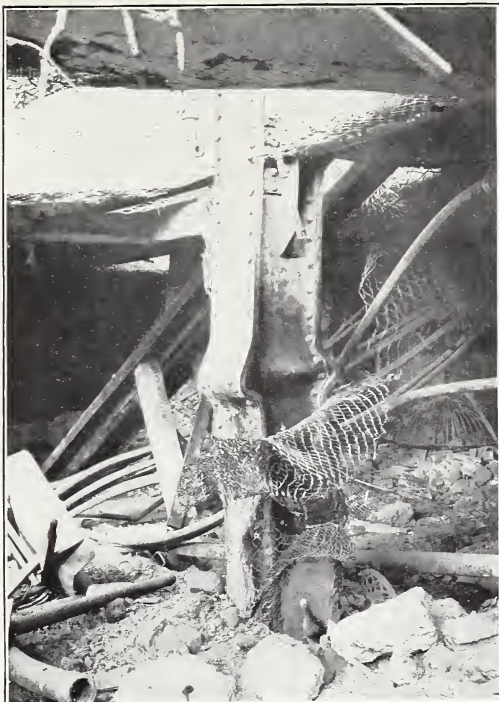
A. BUCKLING OF BASEMENT COLUMN DUE TO FAILURE OF PLASTERED METAL-LATH FIREPROOFING, RIALTO BUILDING, SAN FRANCISCO.

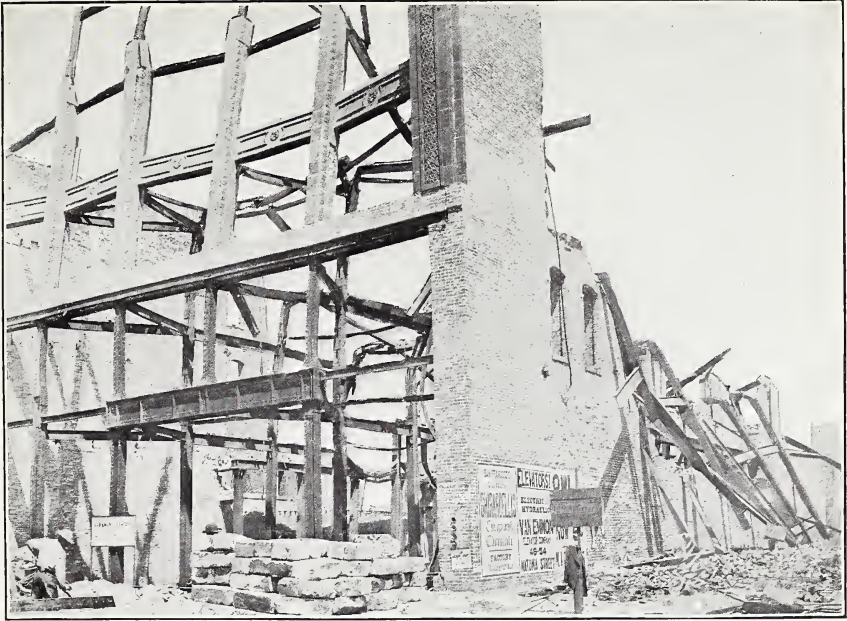
A. AN UNFINISHED STEEL SKELETON, WITH NONFIREPROOFED STEEL WORK.

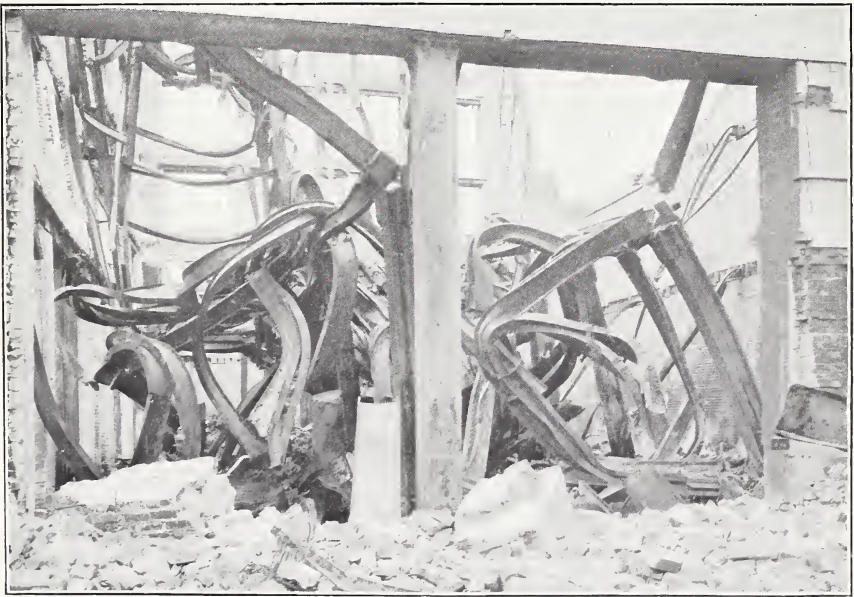
B. UNPROTECTED STEEL FRAME AND GENERAL FLIMSY CONSTRUCTION, COWELL BUILDING.

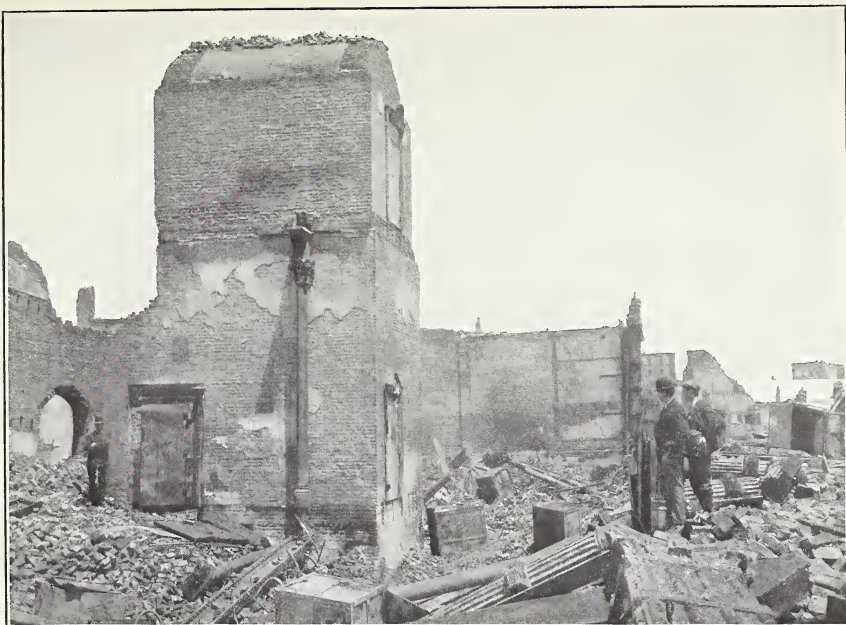
A. ENDURANCE OF BRICK VAULT.

This vault, which was in the original Wells-Fargo Building, San Francisco, passed the fire test satisfactorily, although the building was completely destroyed. Note the defective steel "fireproof" safes near by. Photograph by Richard L. Humphrey.

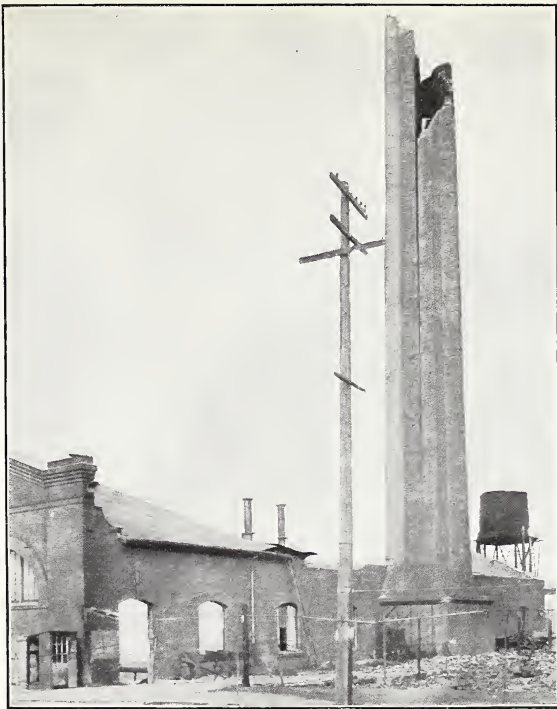
A. EARTHQUAKE DAMAGE TO BRICK STACK OF STAR SECTION, VALENCIA STREET POWER STATION, SAN FRANCISCO.

Showing peculiar crack in reentrant angle. Photograph by Richard L. Humphrey.

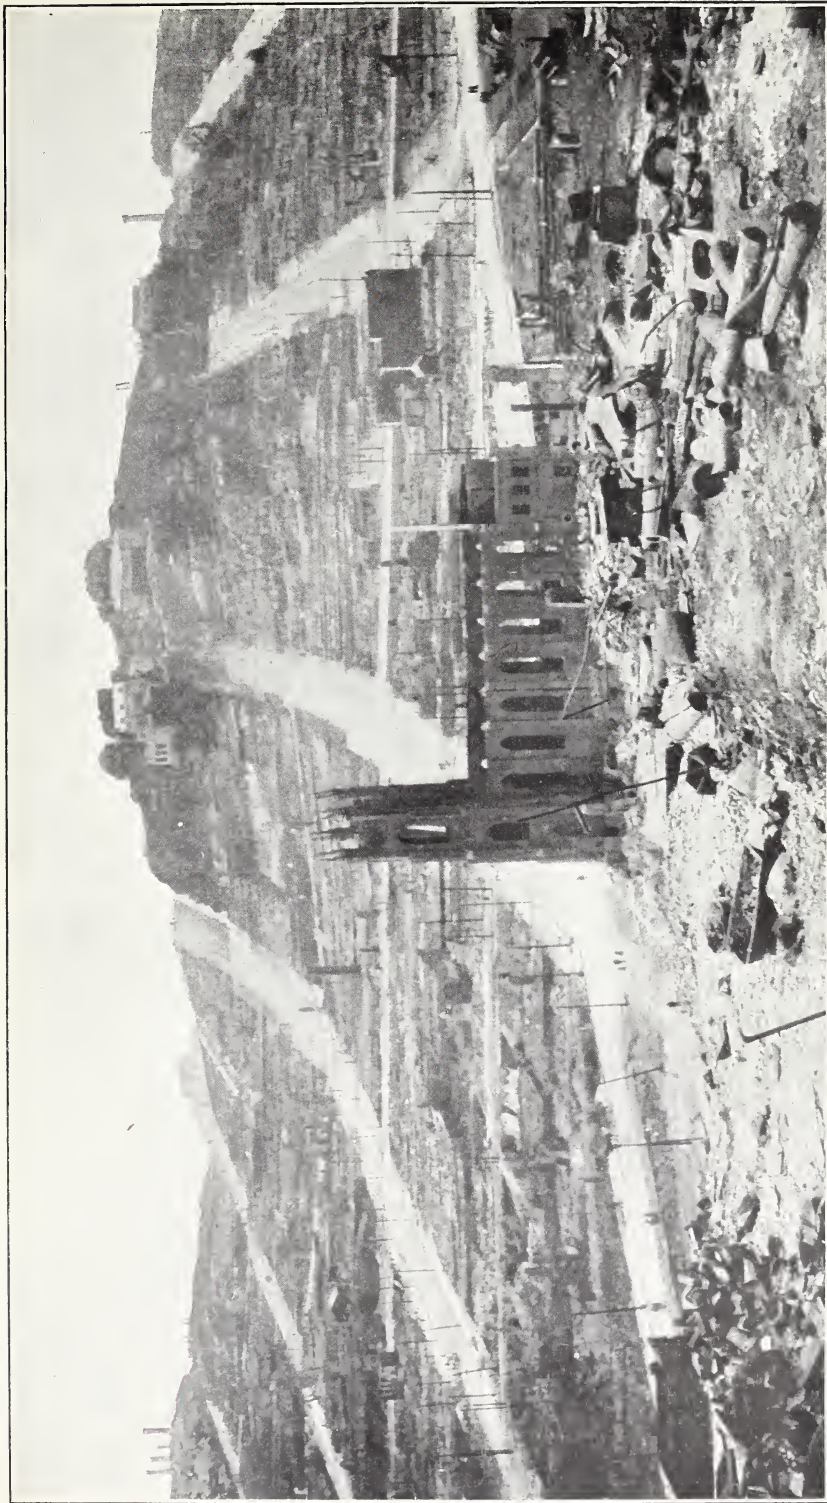
DESTRUCTION BY FIRE, SAN FRANCISCO.

View looking west from Telegraph Hill, showing unburned houses on summit of Russian Hill, St. Francis Roman Catholic Church, with its excellent brick walls, in the foreground. Photograph submitted by Frank Soule.

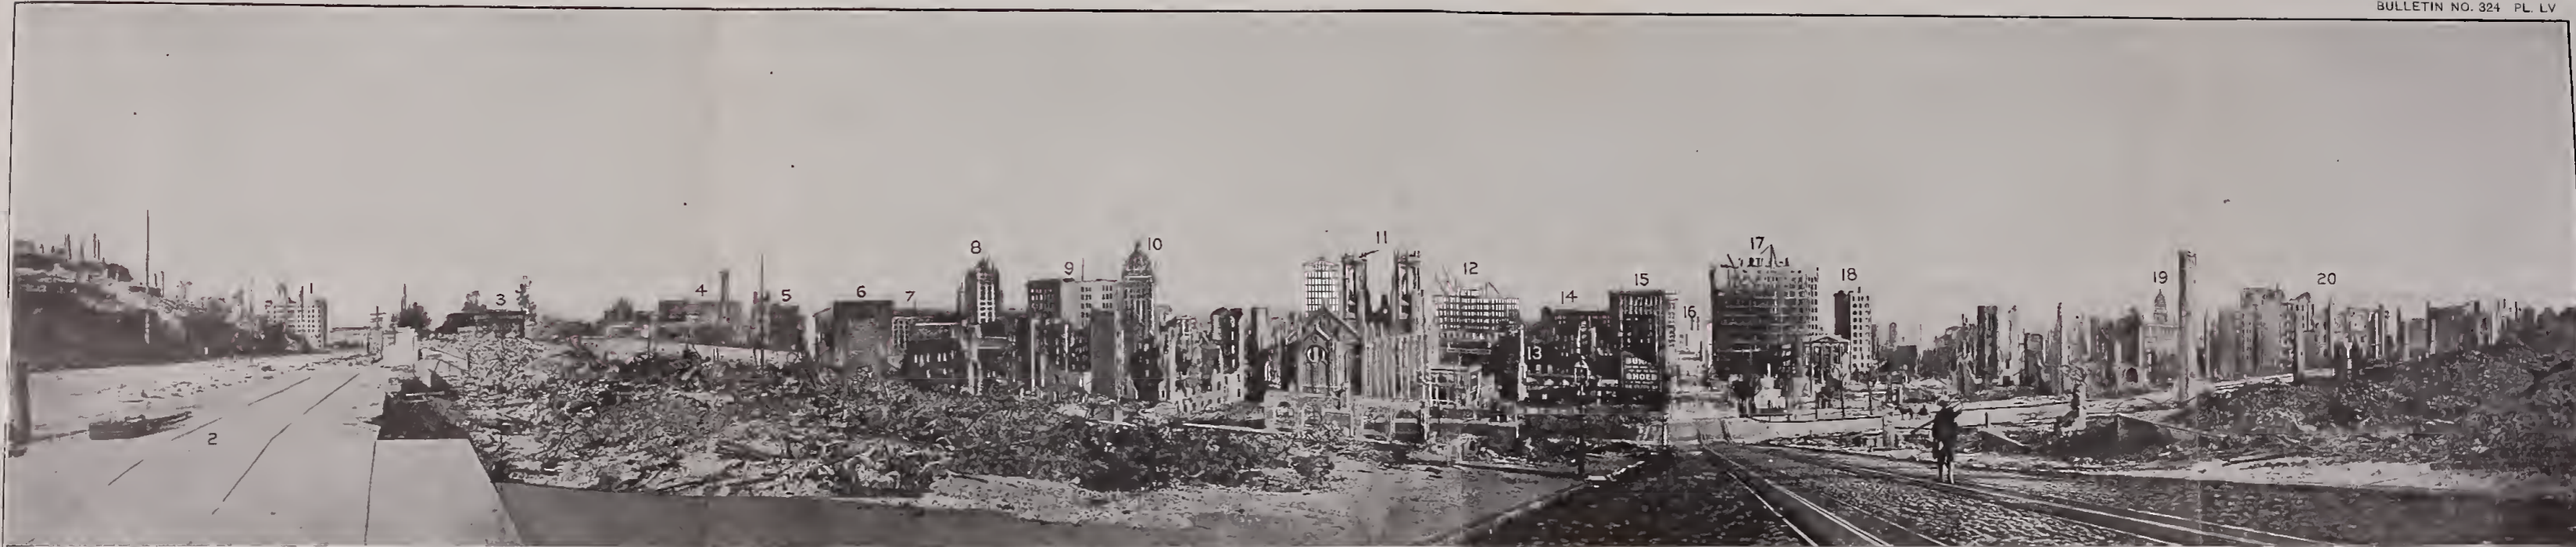
DESTRUCTION BY FIRE, SAN FRANCISCO.

Panorama taken at corner of Pine and Powell streets, showing location of principal buildings in the area south of Pine street. Photograph by John Stephen Sewell.
